FLEXIBLE DOWNDRAINS

Equipment Development and Test Report 7700-6

JANUARY 1974

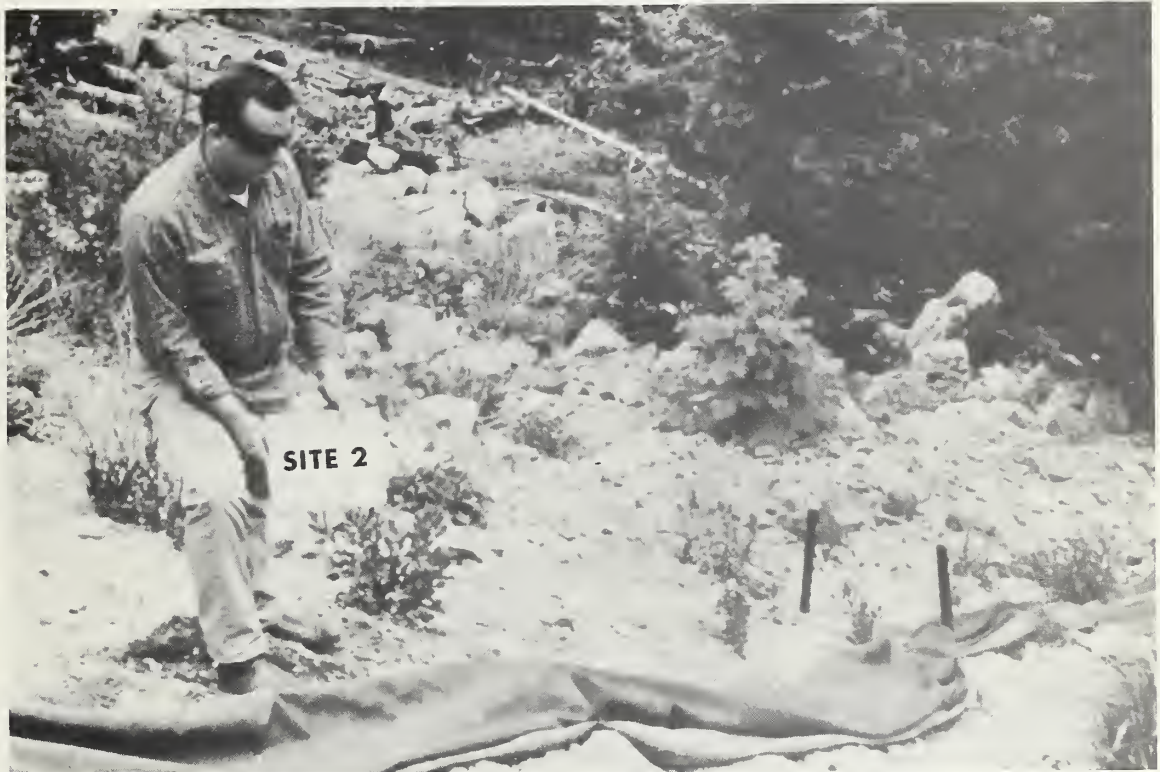
The first failures were found in March 1969 by personnel of the Southwestern Region. Wind blew the unsecured tubes about, causing abrasion of the downdrain on the rocky fill slope. One downdrain was abraded so badly that it had to be removed and discarded. Three others were damaged, but not seriously enough to impair their effectiveness. An attempt to rectify this condition was made by staking and wiring at intervals of about 50 ft, and by lacing the bottom of the downdrain to a wire staked into the ground (see fig. 3). This did not prove satisfactory because down-drains were wrapped around the stakes by the wind. This led to a modification which incorporates grommets for staking down the downdrains.

Figure 3. Post and wire tie down method used to prevent downdrains from blowing.

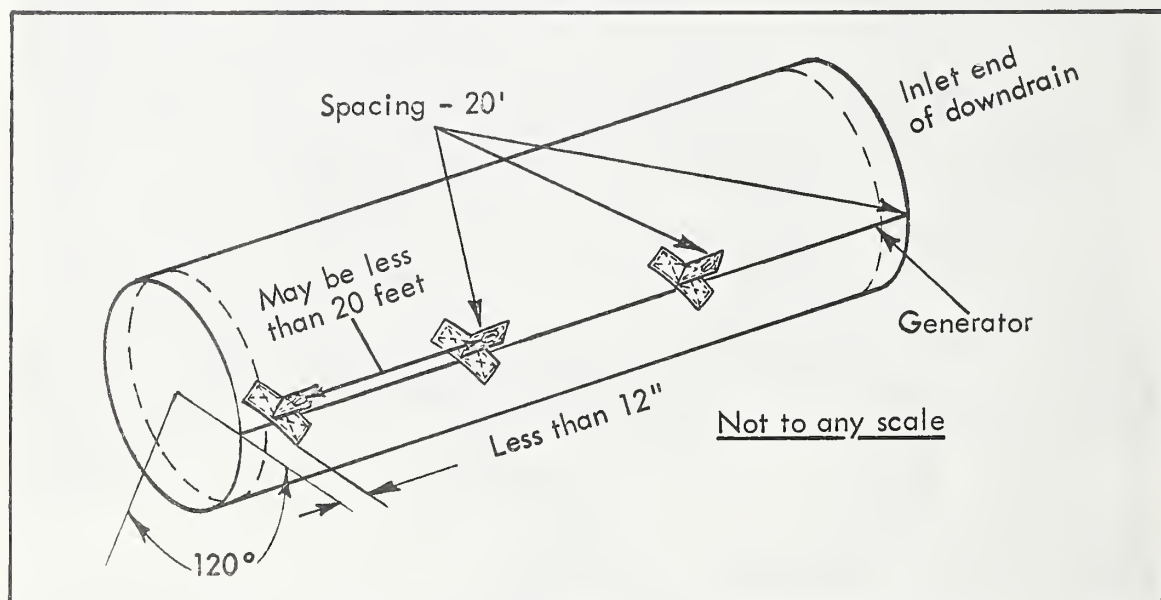
Figure 4. Modified downdrain design, two rows of grommets 120° apart.

The new downdrains were constructed from Relgard 16 oz neoprene. Grommets were spaced every 20 ft and double stitching at the seam was specified.

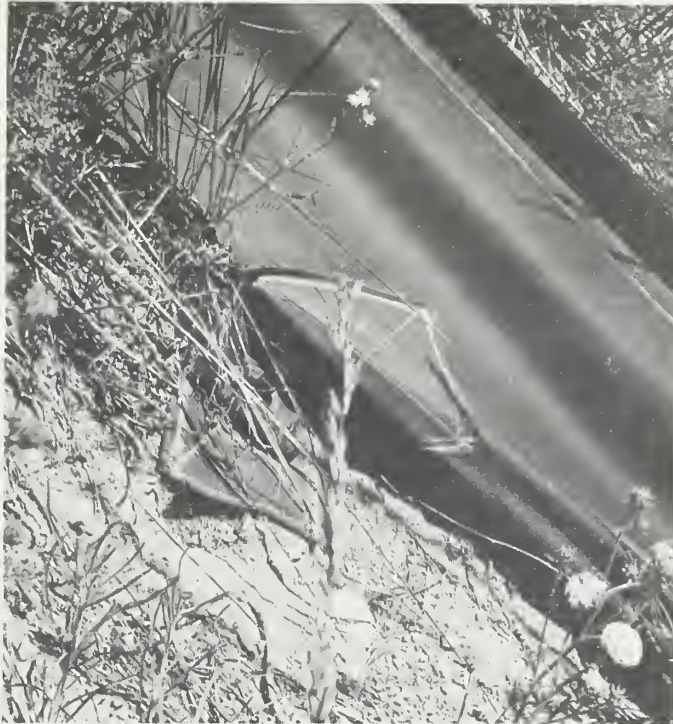
Neoprene was utilized to minimize the rodent problem. The grommets allowed the downdrains to be staked to the ground preventing them from being blown about by the wind.

Figure 5. Grommet and stake used to prevent movement of down drain.

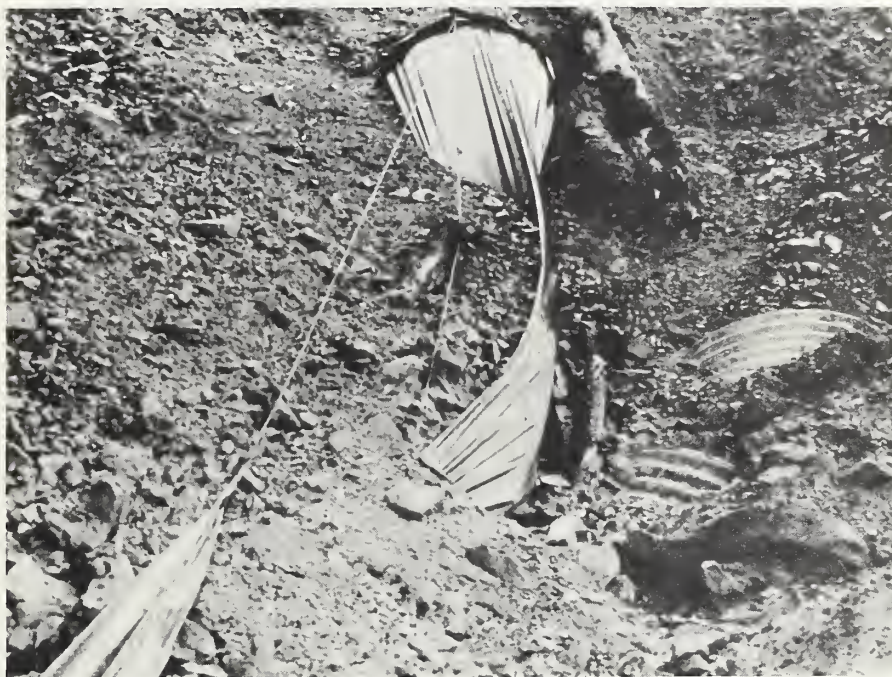
The Mendocino National Forest installed two modified, grommited, neoprene down-drains during 1969 near the sites of the original installations. One of the units was in excellent condition. The second was installed on a fill slope that had previously slipped and destroyed a 30-in. corrugated metal pipe. A great deal of earth slid down on top of the downdrain, completely destroying it.

Figure 6. Fill-slope failure--30-in. downdrain.

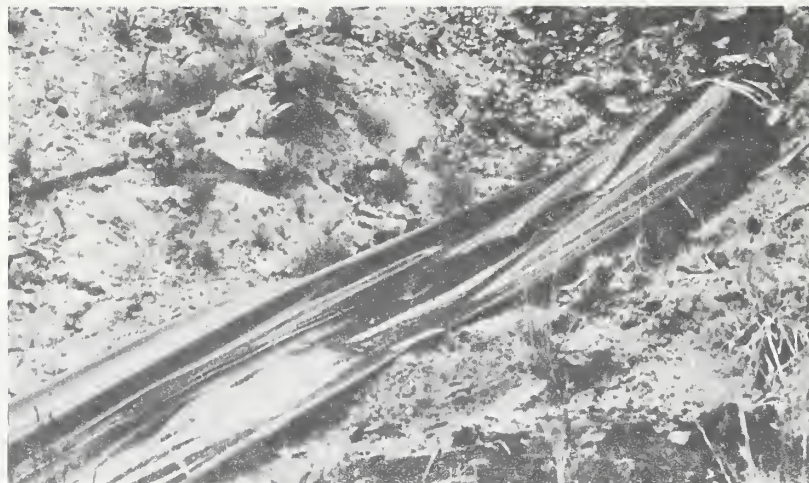
The Umpqua National Forest installed two modified downdrains on newly placed culverts in 1969. After 33 months both tubes were in perfect condition, but the nylon attachment strapping had failed because of weathering. Figure 7 shows one of the installations.

Figure 7. Pacific Northwest Region down drain installation.
